DARTBROOK MINE

ANNUAL REVIEW 2022

for Australian Pacific Coal

31 March 2023

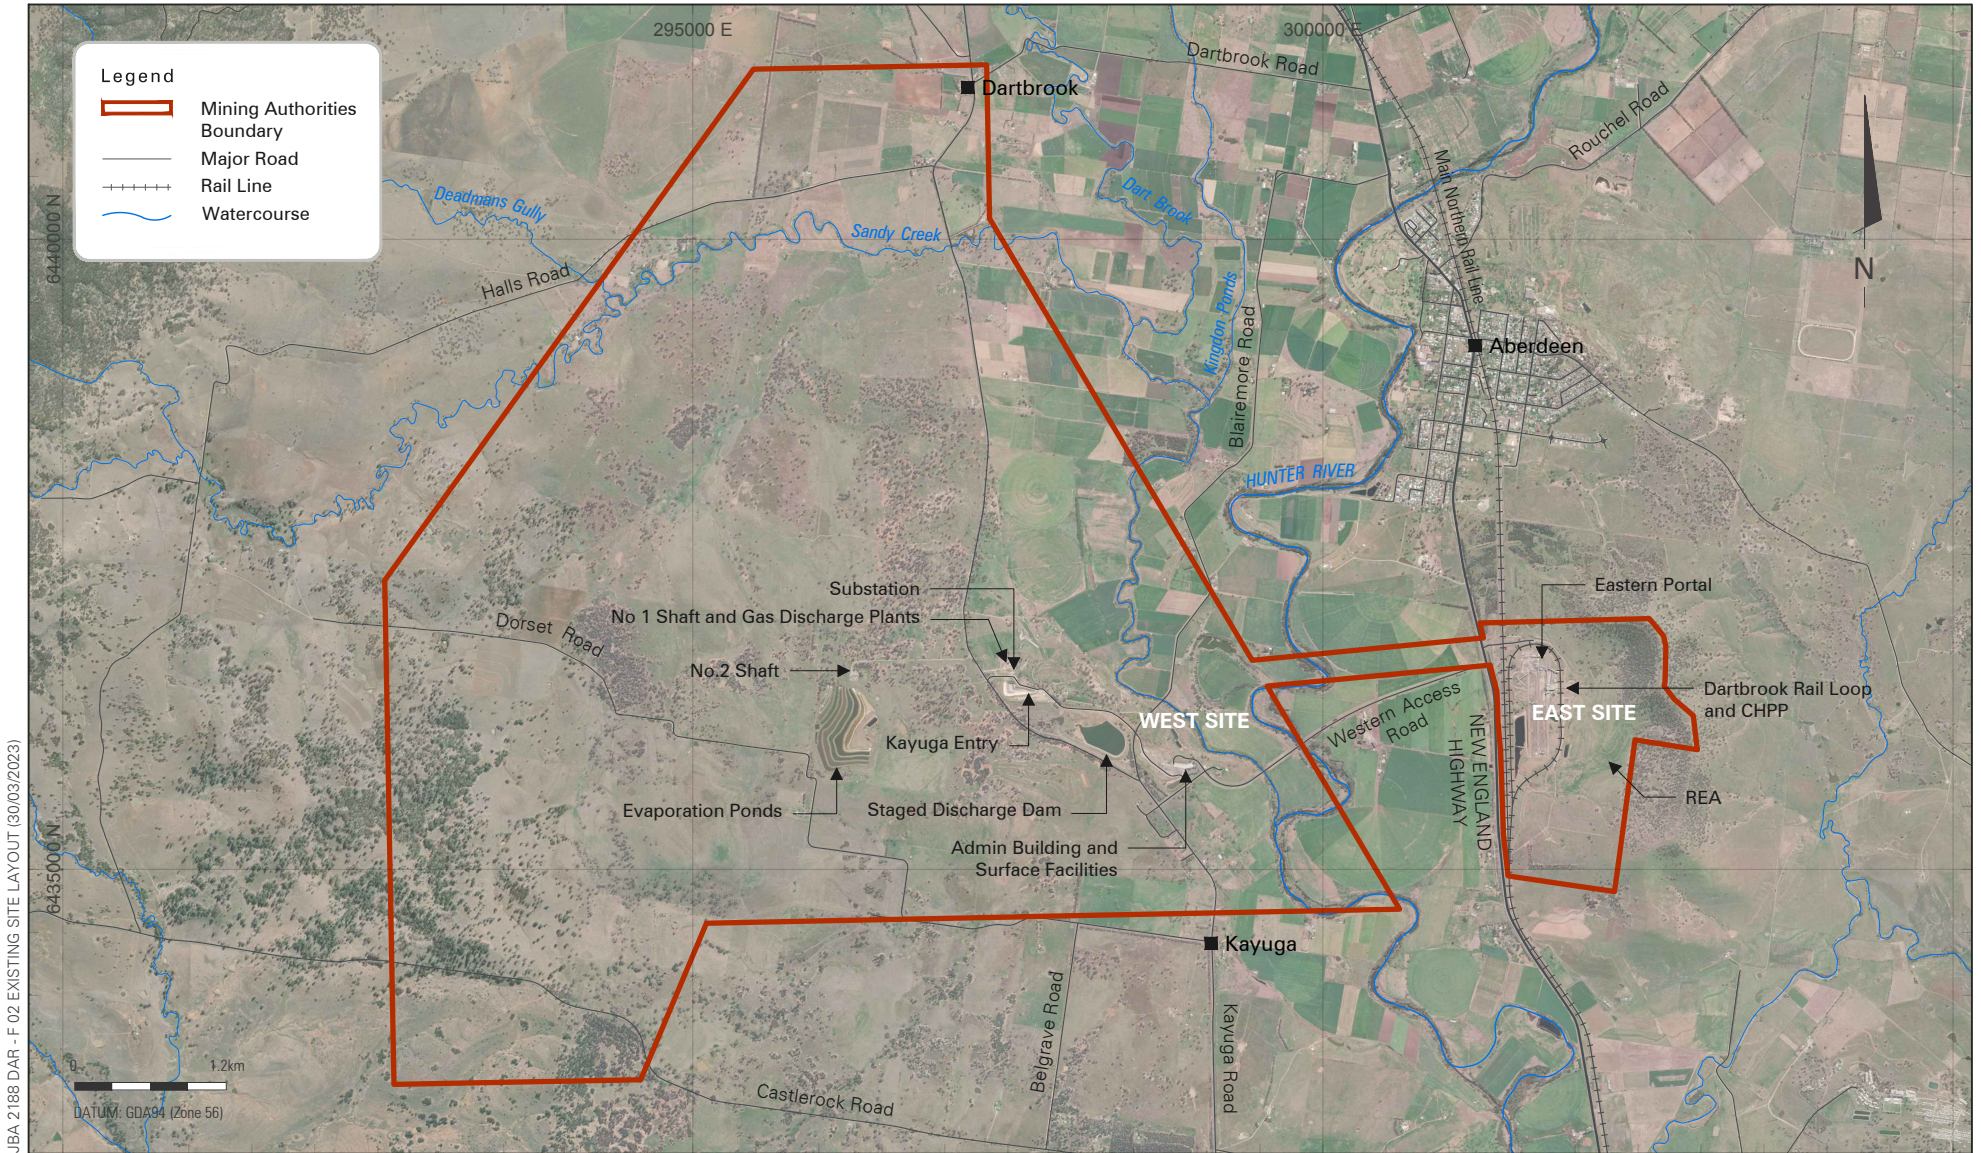
FIGURE 2

JBA 2188 DAR - F 02 EXISTING SITE LAYOUT (30/03/2023)

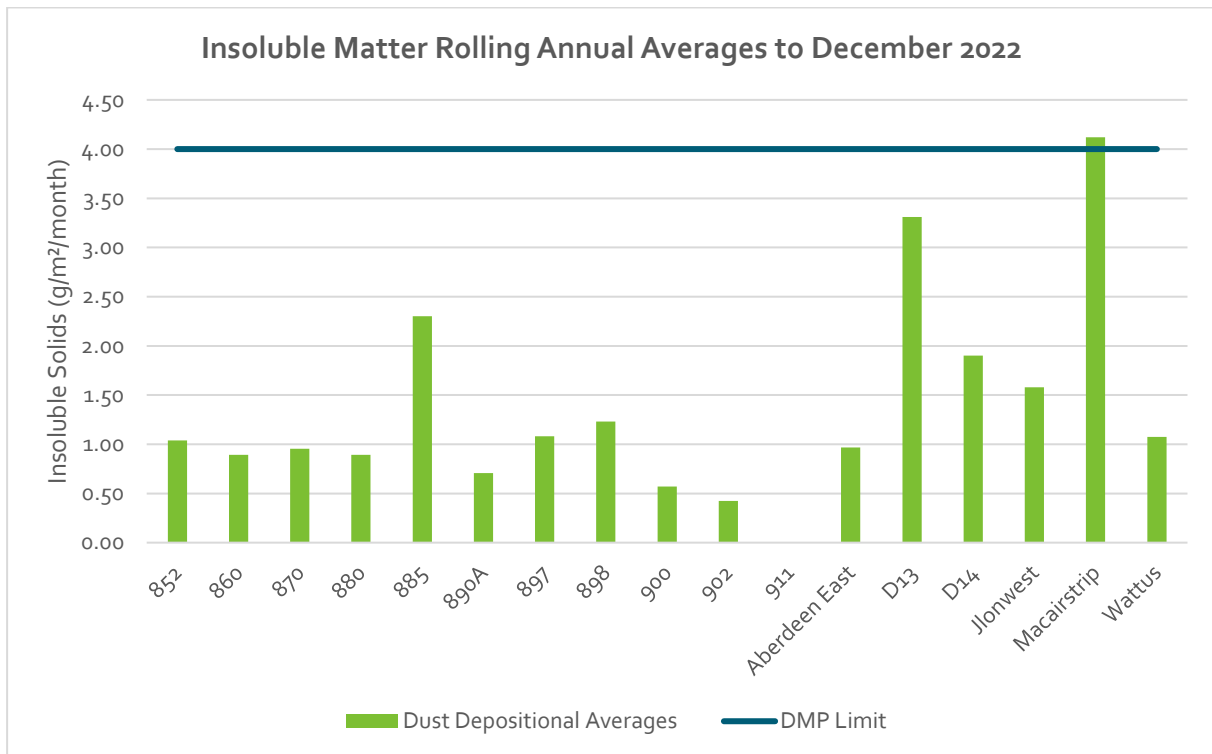
Figure 7 Depositional Dust Annual Averages 2022

Site	Location Description	Insoluble Solids (g/m ² /month)	Number of Samples
852	Dorset Road	1.04	12
860	No. 1 Vent Shaft	0.89	12
870	Kayuga Village	0.95	11
880	Hunter River / Dart Brook Junction	0.89	12
885	Frazer Farm paddock near Hunter River	2.30	12
890a	Garoka Dairy	0.71	11
897	Eastern Site North	1.08	10
898	Eastern Site West	1.23	9
900	Eastern Site South	0.57	10
902	Aberdeen Tree Screen	0.42	12
911*	Browns Mountain	0	0
Aberdeen East	South east of Aberdeen	0.97	2
D13	Residence northwest of CHPP	3.31	12
D14	Southwest of CHPP	1.90	12
JLON West	Residence south of West Site	1.58	9
Macairstrip	Northwest of West site	4.12	12
Wattus	Between Dart Brook and Hunter River	1.08	12

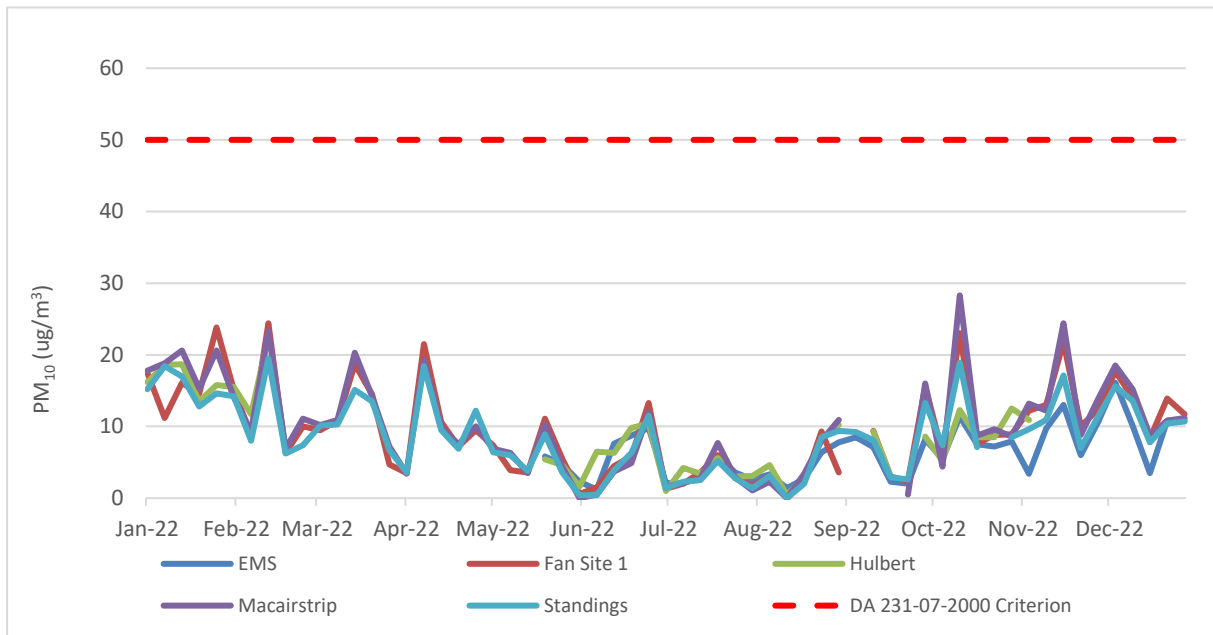
Figure 8 HVAS 24-hr Average PM₁₀ Results 2022

Location	Units	EIS Predicted Annual Average PM ₁₀	Annual Average PM ₁₀ Results 2022
ESMS	µg/m ³	20.1	6.4
Fan site 1	µg/m ³	18.7	10.0
Hulbert	µg/m ³	17.4	8.6
Standings	µg/m ³	17.3	10.0
Macairstrip	µg/m ³	17.0	8.7

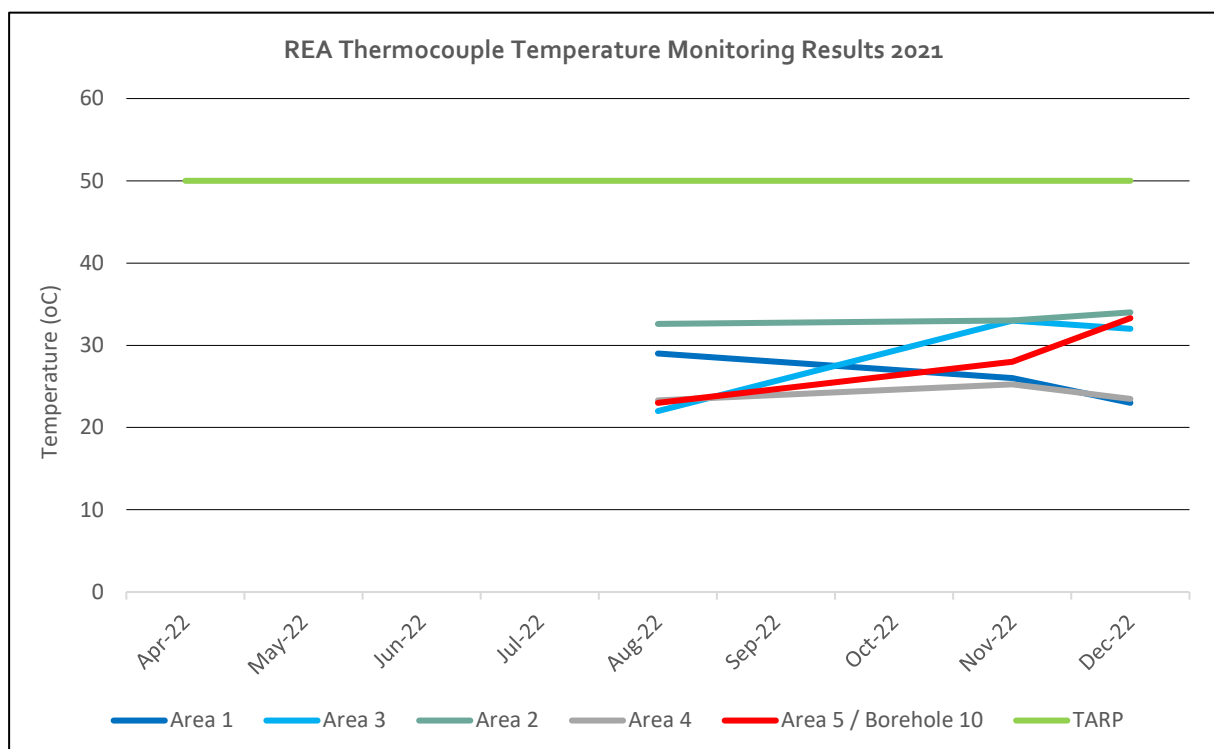
Figure 10 REA Thermocouple Temperature Monitoring Results 2022

The REA underground temperature is monitored using 13 thermocouples installed in boreholes to measure the temperature of the reject's material. **Figure 10** provides the results of REA thermocouple monitoring from the reporting period. REA temperature monitoring did not take place across any sites from April to August 2022 due to the unsafe nature of the access tracks.

Appendix D shows the REA temperature monitoring summary from 2001 to the end of the reporting period.

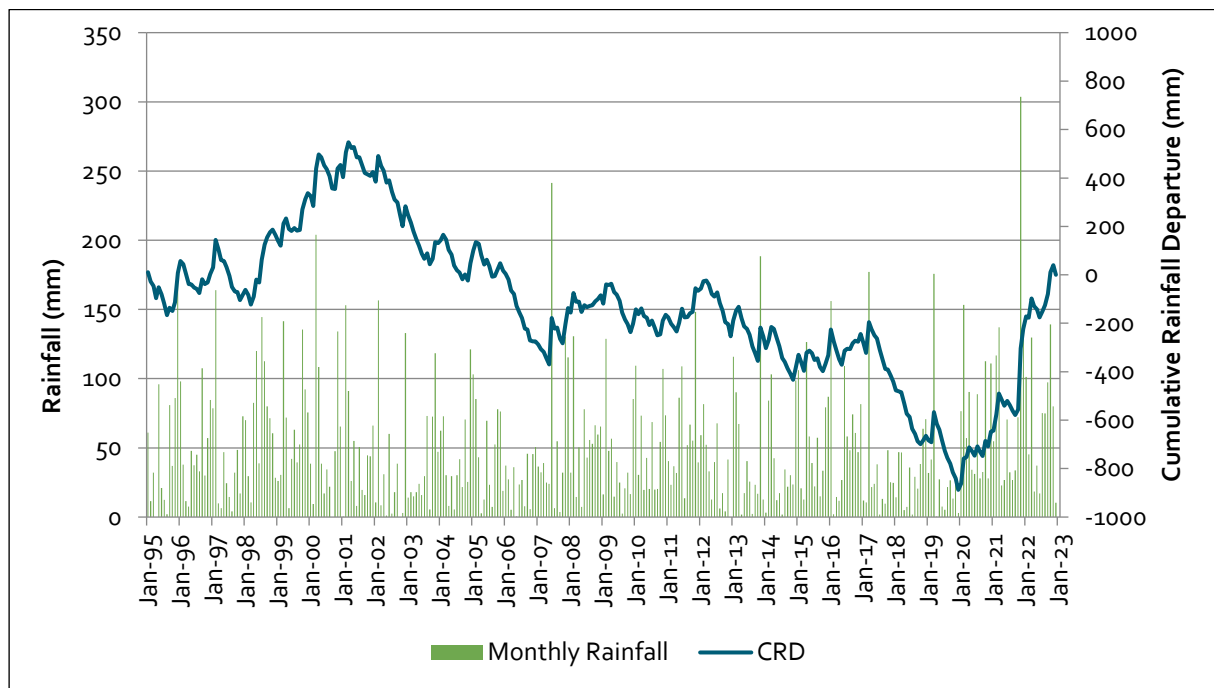
Figure 12 Cumulative Rainfall Departure

As reported in **Section 6.2**, Dartbrook experienced above average rainfall in 2022, as reflected by the rising trend in the CRD.
